FINAL REPORT

LAKE ENHANCEMENT PROGRAM
FEASIBILITY STUDY
FOR
LAKE SALINDA

THE CITY OF SALEM
City Building
Salem, IN 47167

March 21, 1990

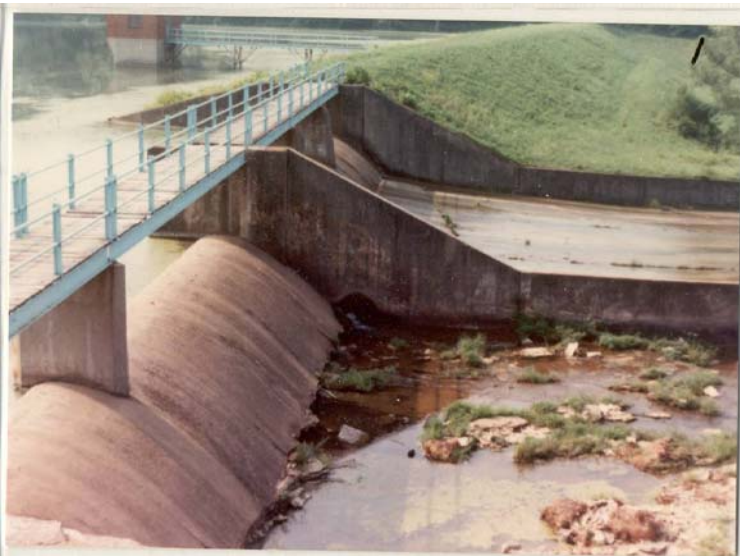
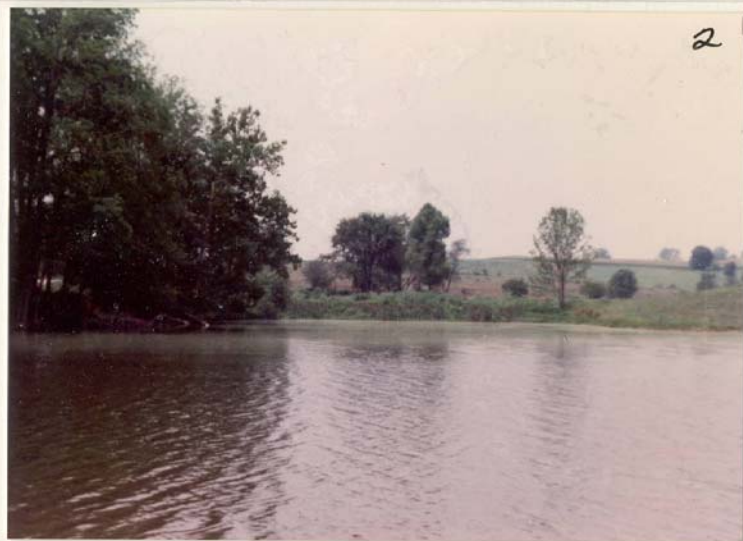
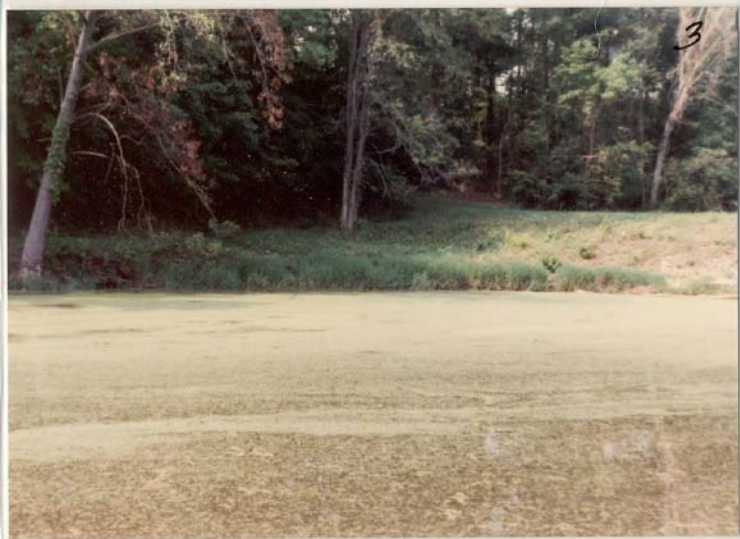
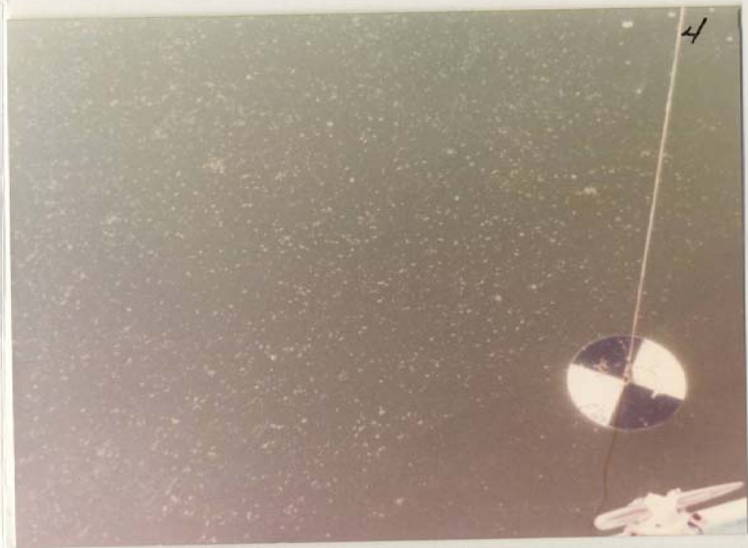
INDEX OF PHOTOGRAPHS
LAKE SALINDA

<u>PHOTO #</u>	<u>DESCRIPTION</u>
1	Lake Salinda Dam and Spillway, shows sampling stations LS1, and LS2.
2	Watershed Section 6, shows emergent plants and land use/topography in basin.
3	Pool near Dam and LS2, shows Duckweed covering lake surface.
4	Secchi Disk being submerged @ station LS2.

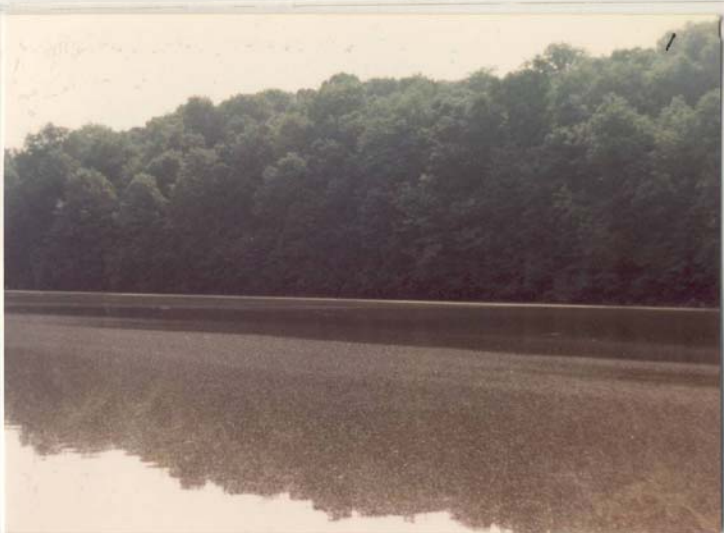
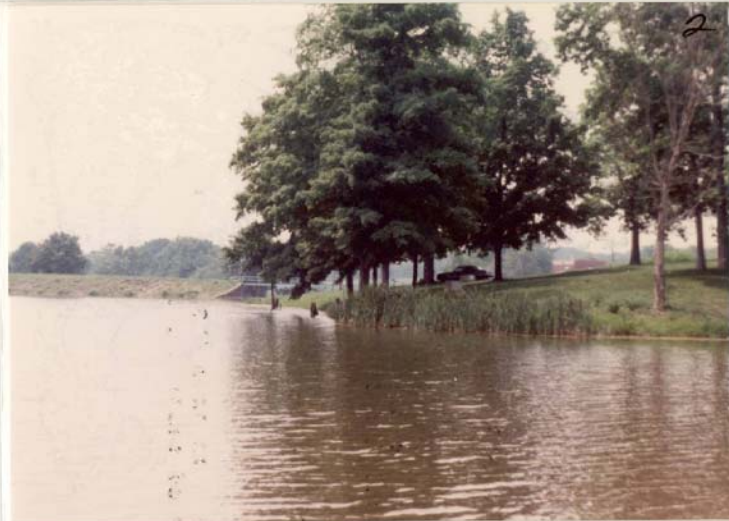
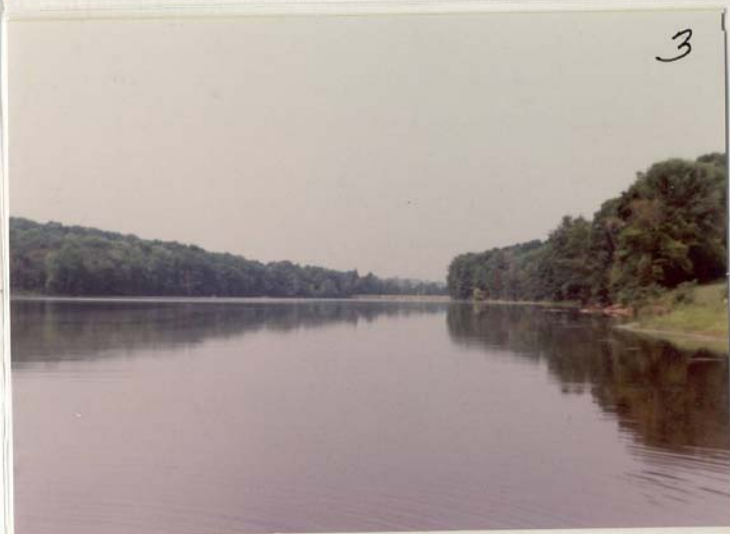
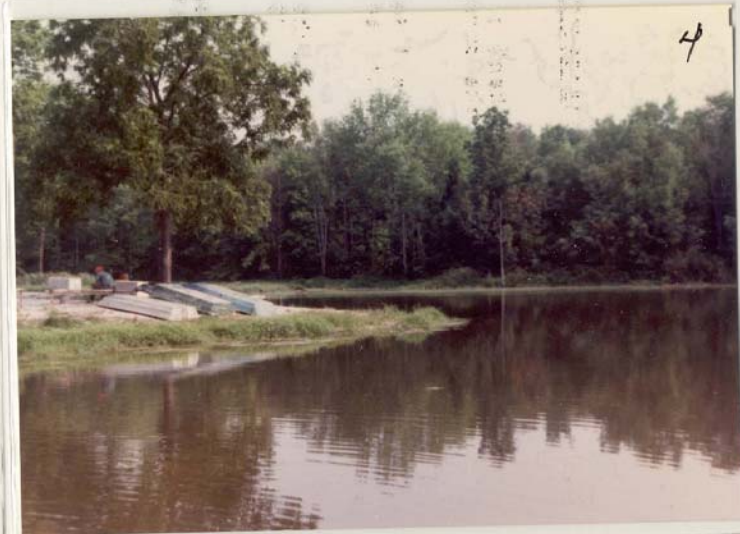
- 1 Left bank near station LS2 showing Duckweed on Lake surface.
- 2 Watershed Section 6 outlet, showing cattails near shore and dam in background.
- 3 View of Lake pool and dam from near stations LS3.
- 4 View from boat launch area (LS4) shows outlet of watershed section 5 in background.

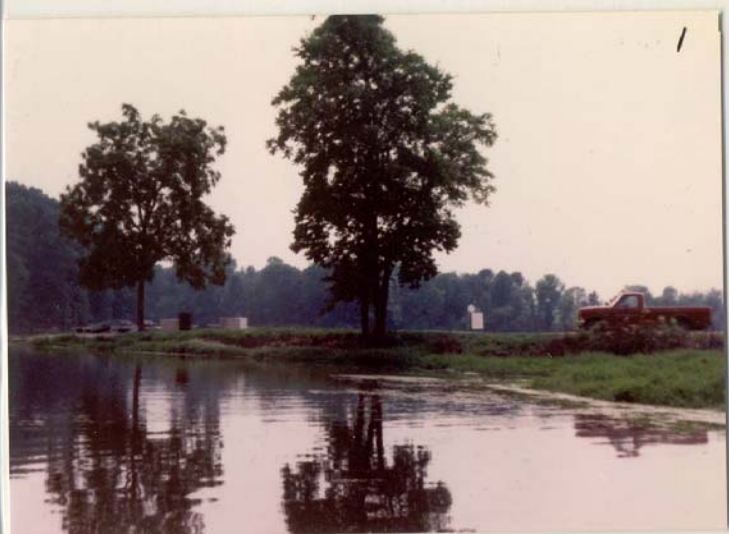
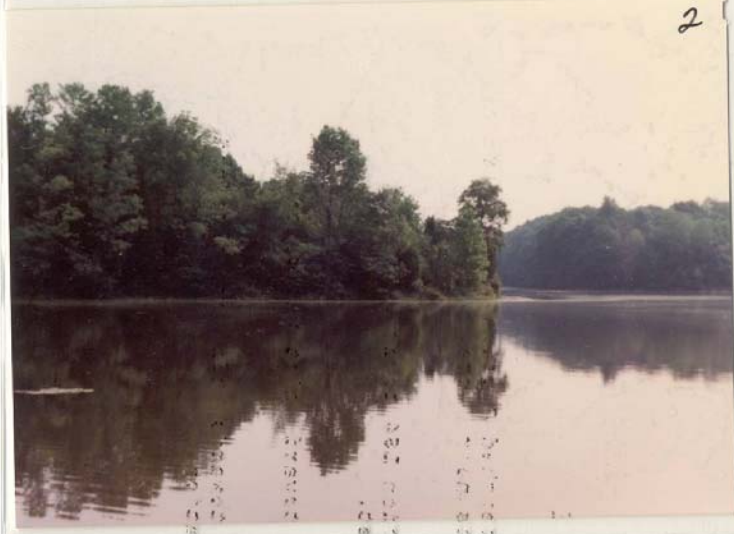
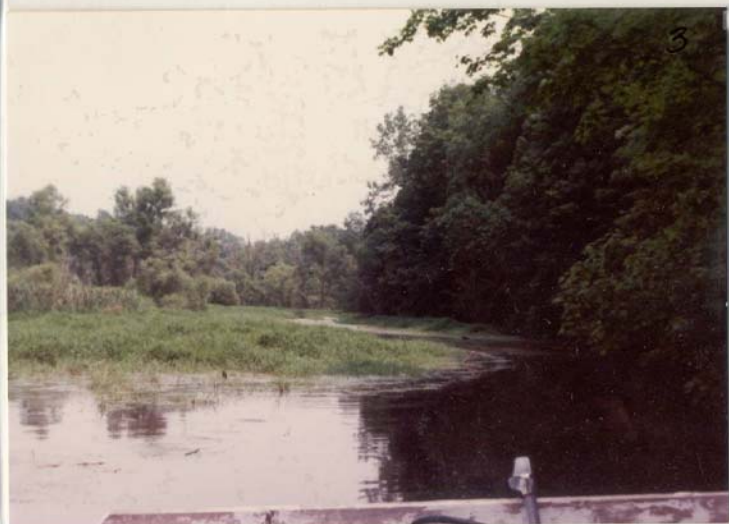
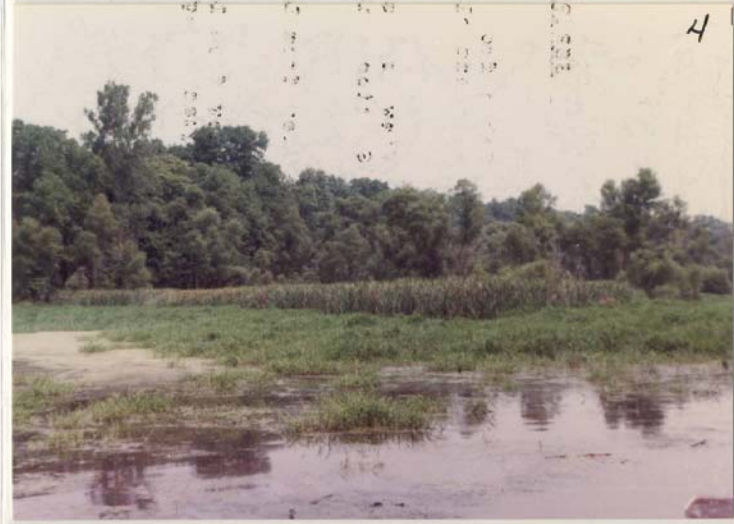
- 1 Taken from Watershed Section 5 inlet, shows
 emergent plants near shore.
- 2 View from station LS4 towards LS5 and
 Section 4 inlet.
- 3 View from LS5 toward inlet watershed.
- 4 View from LS5 towards sediment delta and
 aquatic vegetation.

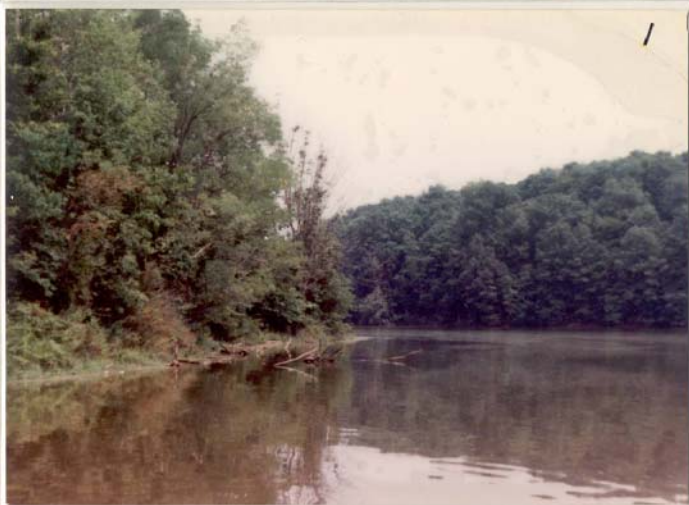
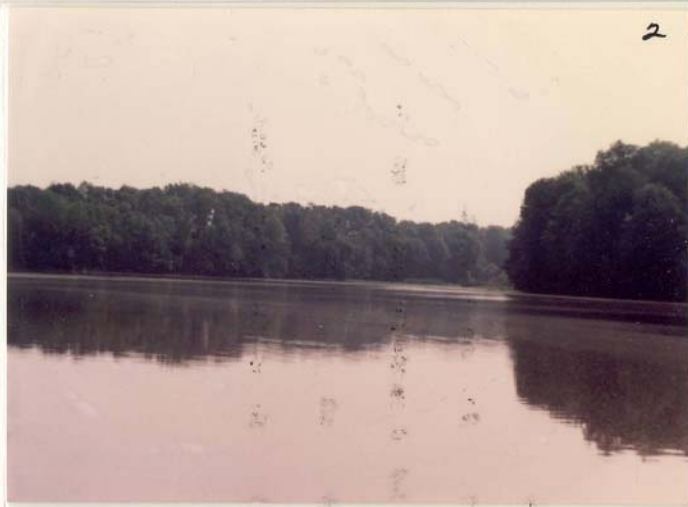
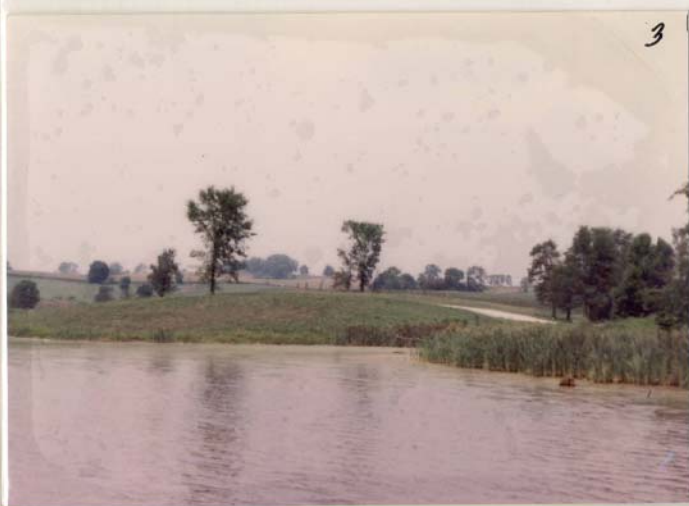
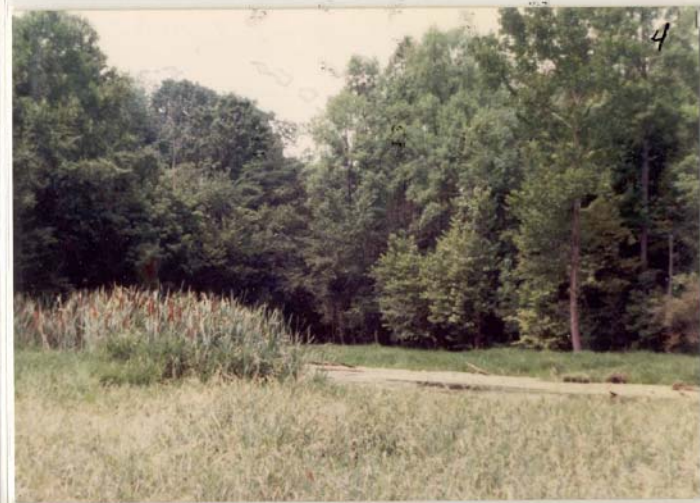
| 3 | Watershed Section 6 showing cattails. |
| 4 | Watershed Section 2 inlet showing emergent plants. |
